Eliminate the residual current following the replacement of bulbs by leds

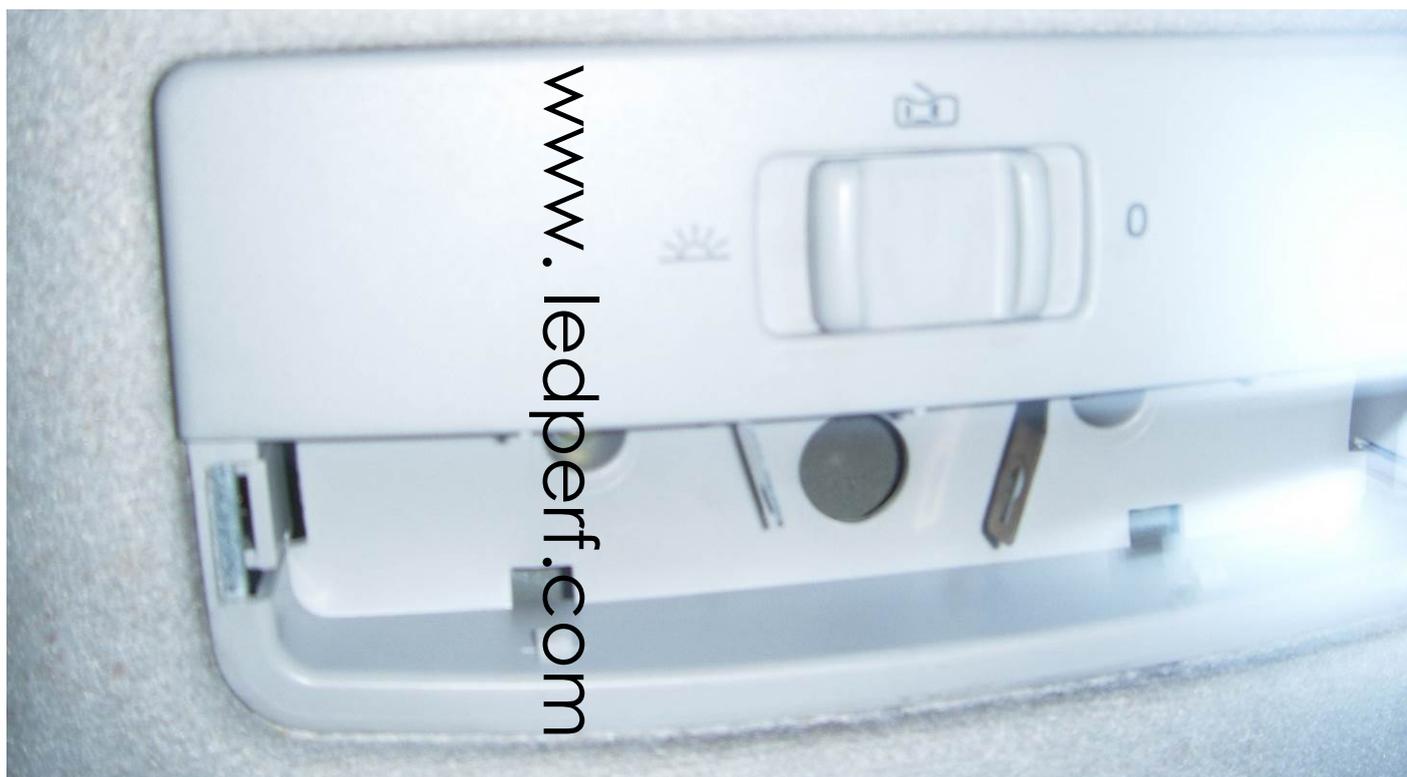
This is a ceiling light in which we removed the original shuttle light bulb:

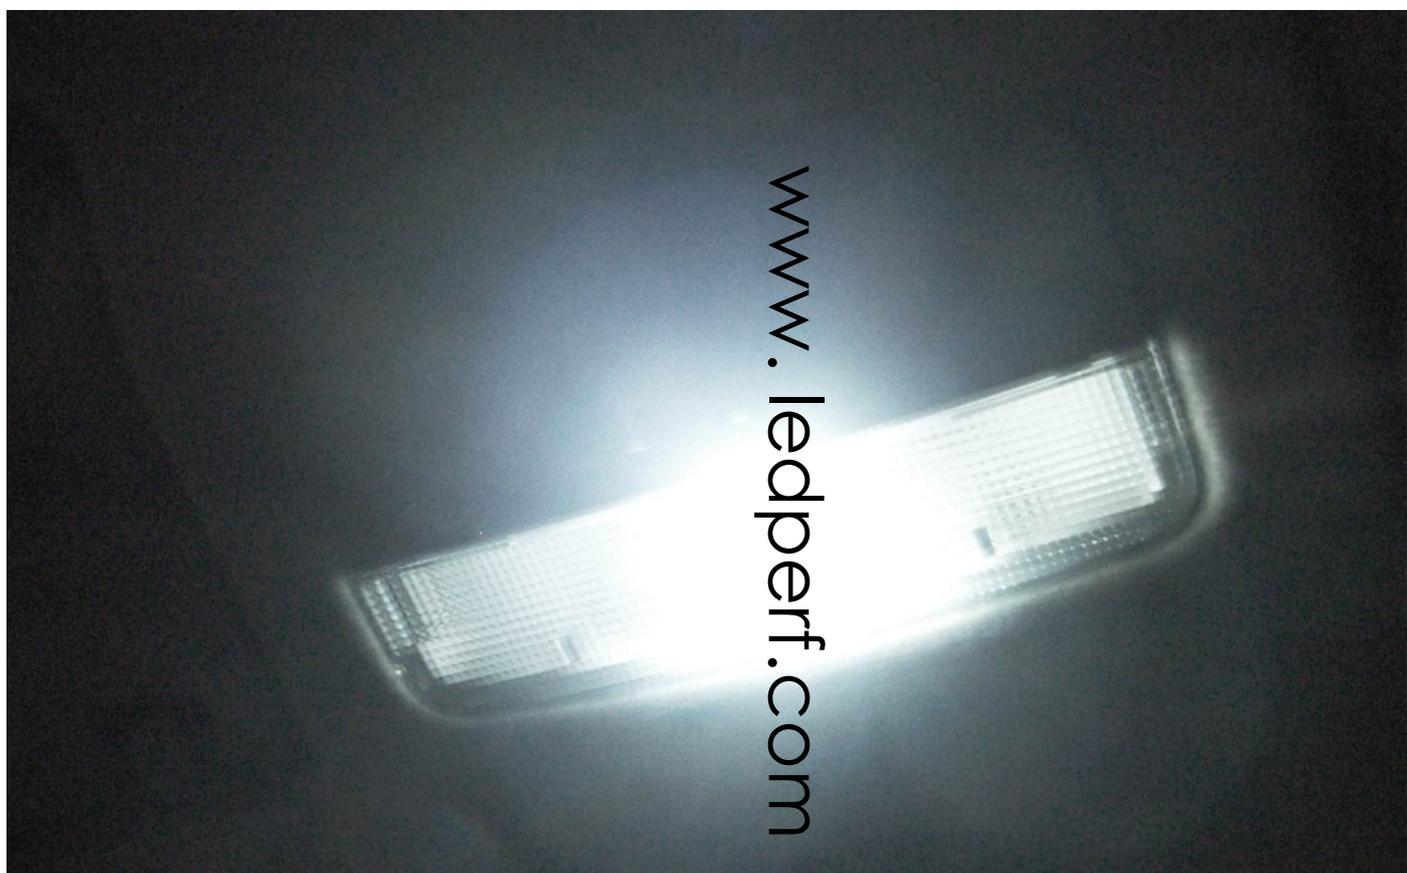
Here is the result once the led is in place:

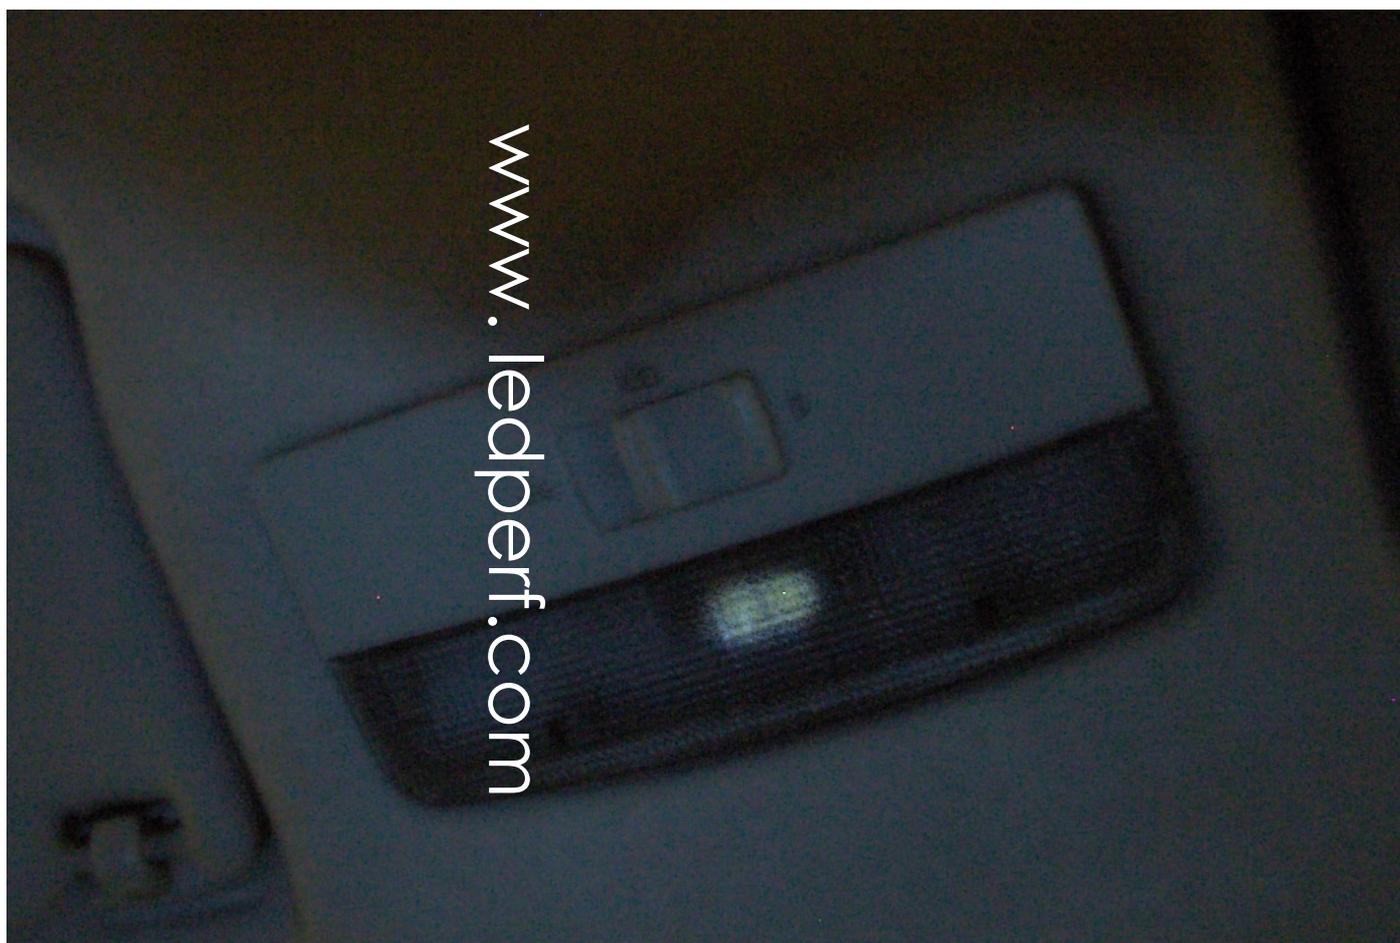
Problem : Same car closed, the led stays very slightly lit:

A very weak current flows in the vehicle, even when the car is closed: this is the residual current. Since the bulbs require a 12V current to operate, they did not light up with the residual current. However, as the consumption of the leds is very low, they light up slightly because of the residual current.

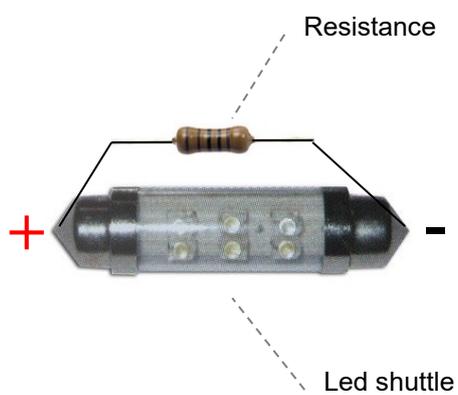
It is useless to weld the resistance. Simply place it in contact with the led. Example with a shuttle led :

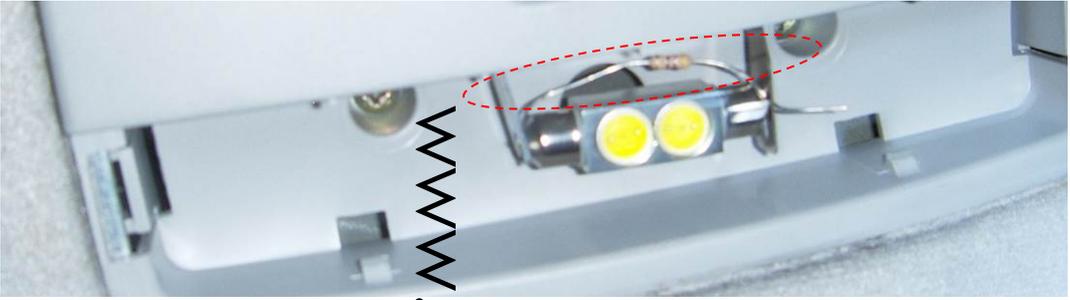
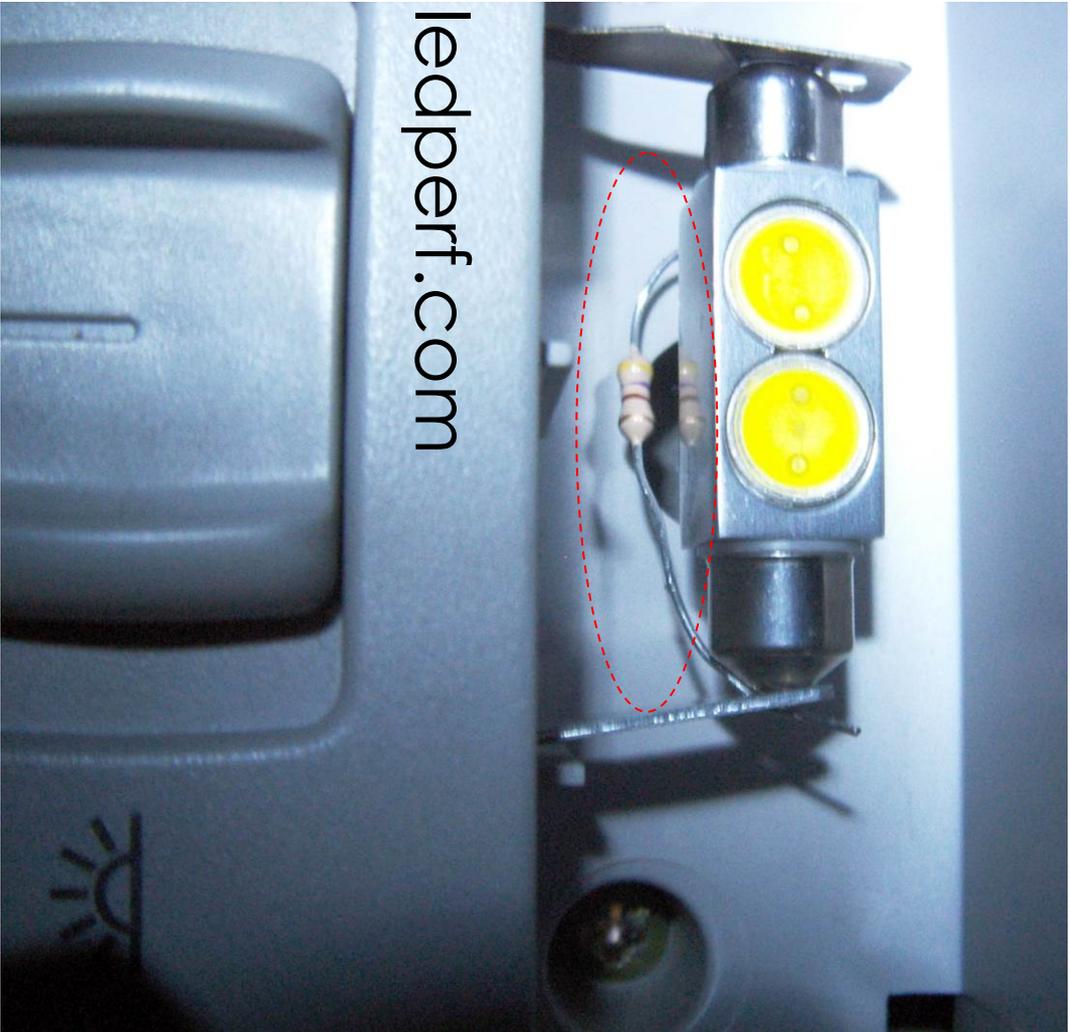
Resistor installed on the ceiling light :

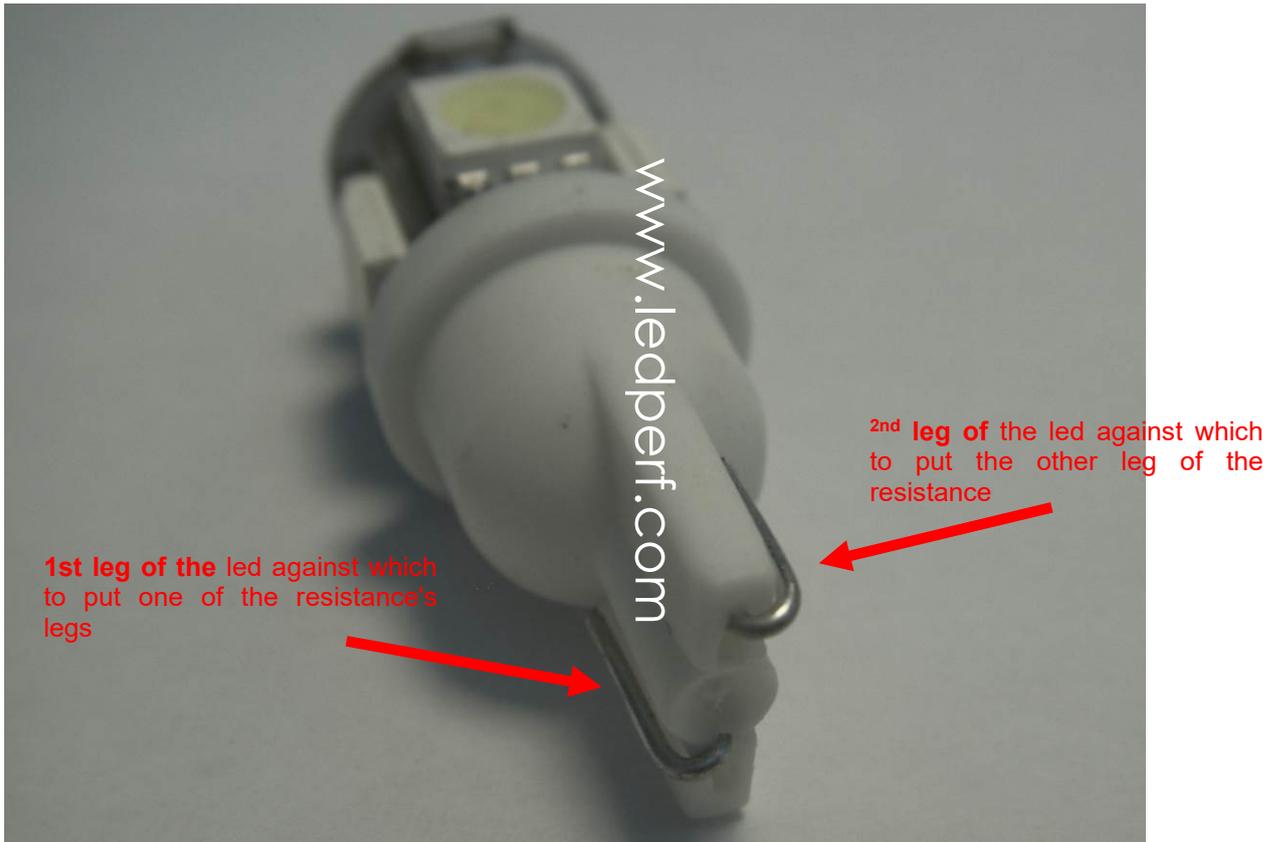
For T10 leds, it is also sometimes necessary to place a resistor. Here's how to place this resistor:

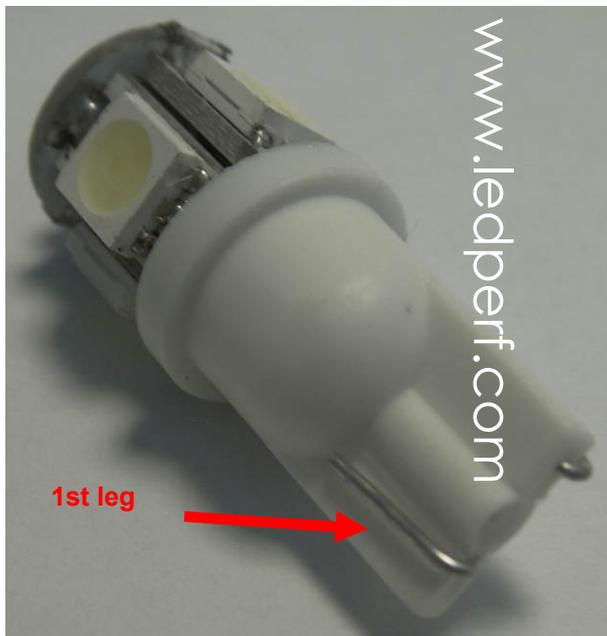
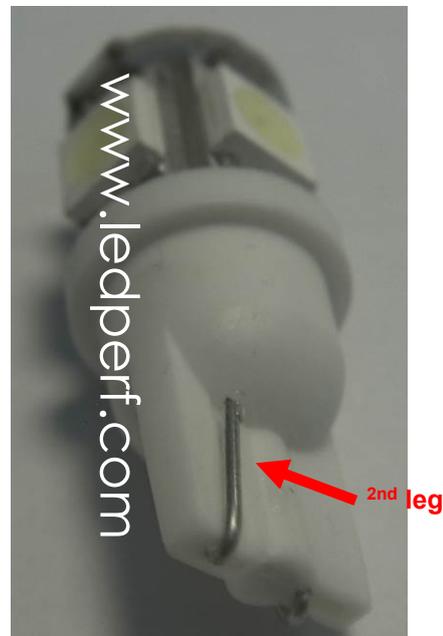
A closer look:

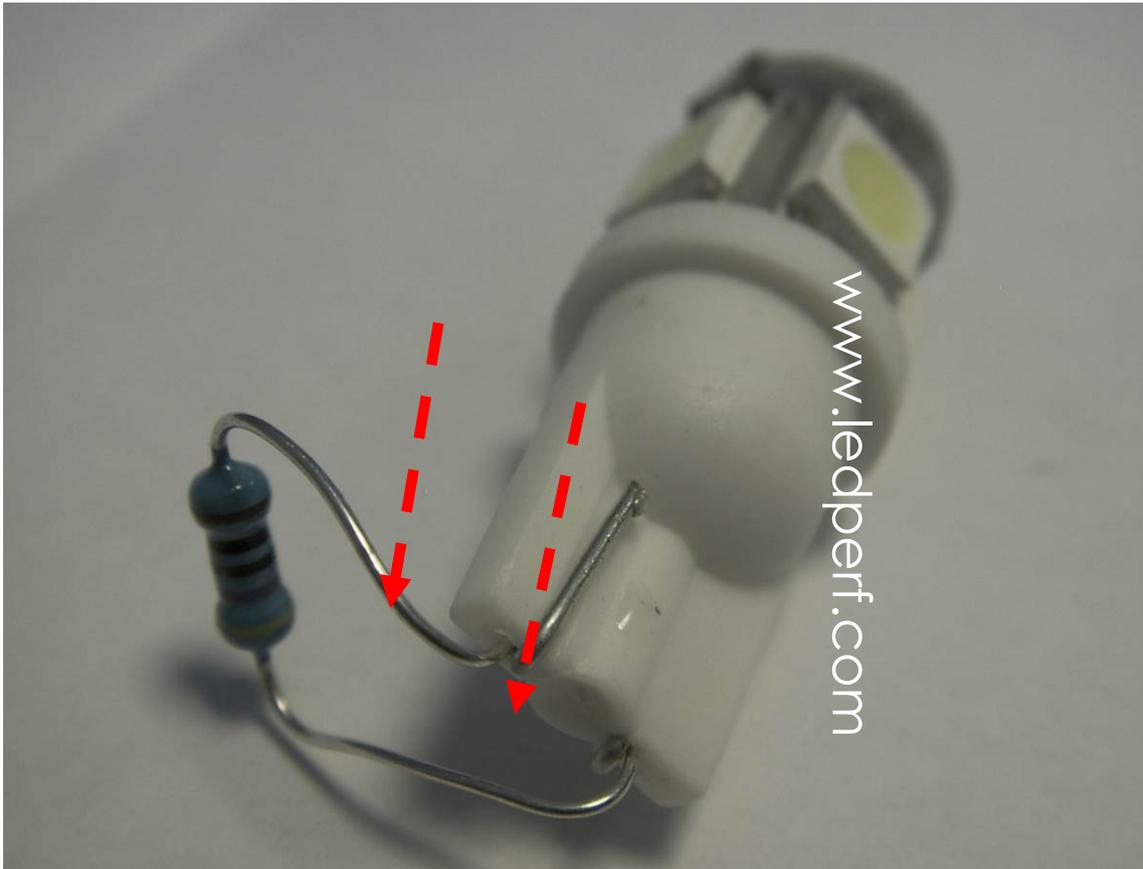
Installation of the resistance in contact with each leg :

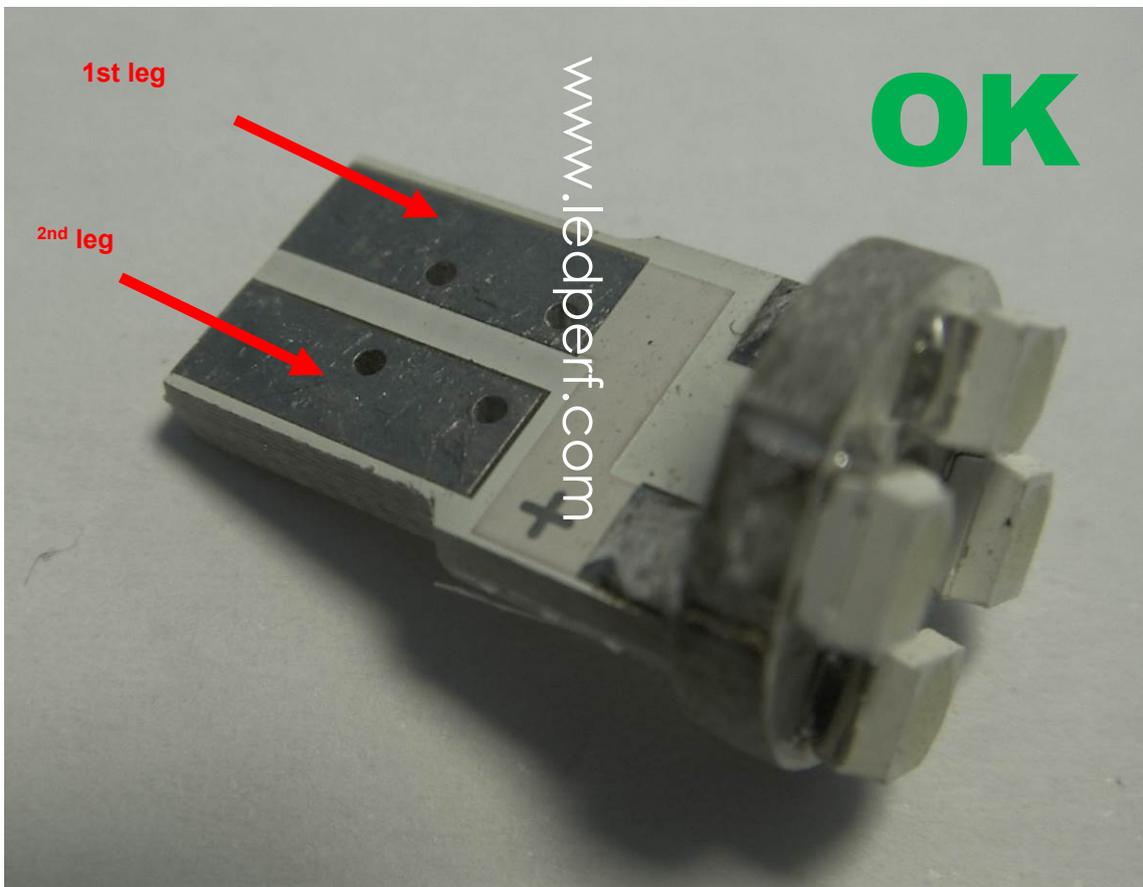
If you are using a T10 Efficacy, the resistor must be put in contact with two contacts of the led, **but only on one side:**

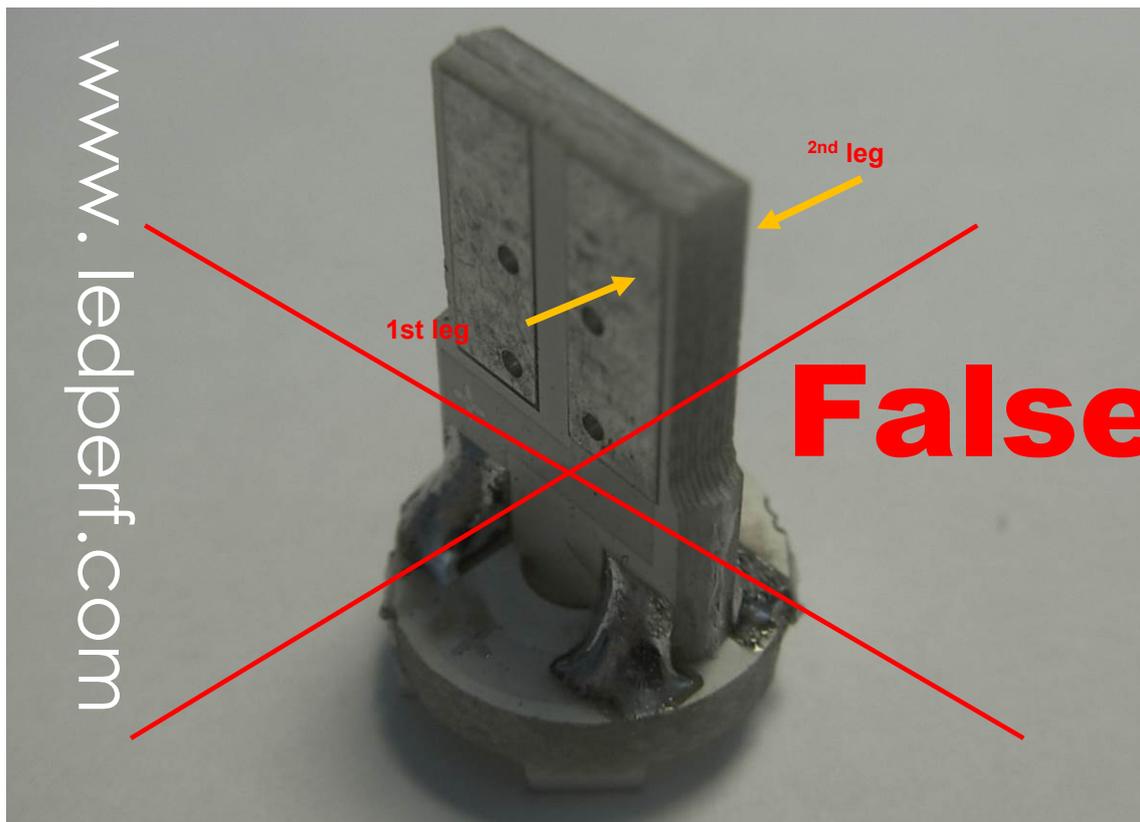
Not to be done (connection of the resistor on each side of the efficiency led):

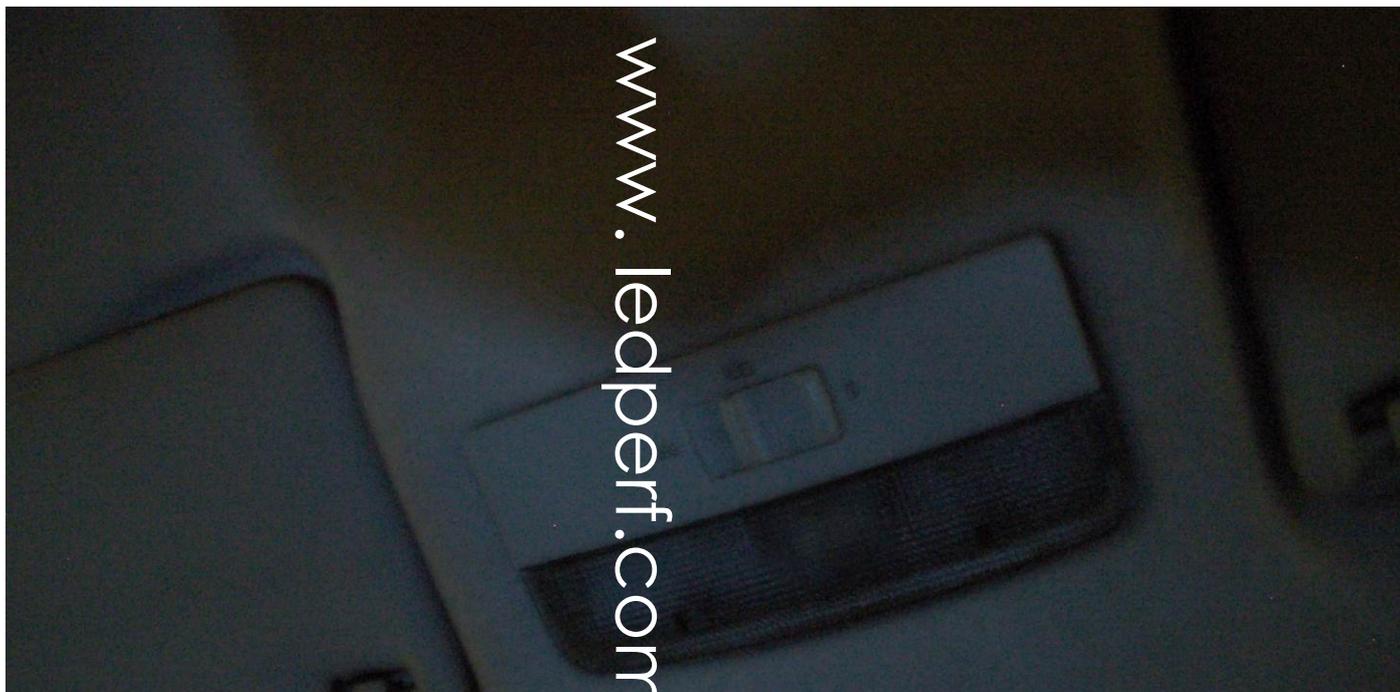
Result once the resistor is placed :

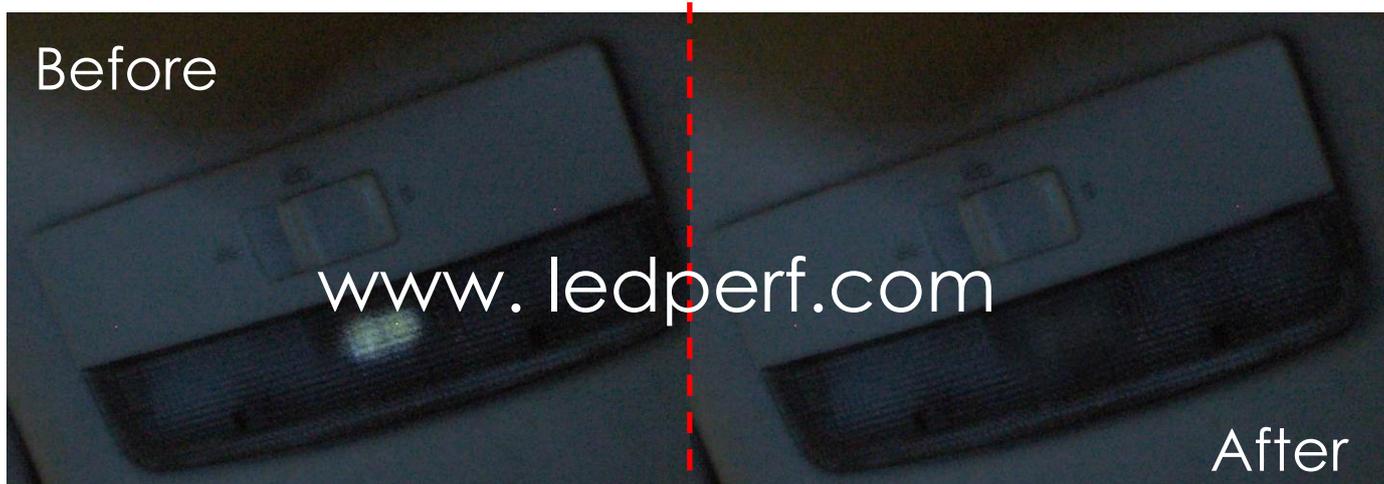
Before / After (car closed)
